*Physical Needs Assessment*

# Happy Community Apts.

111 Sample Blvd.

September 20th, 2014

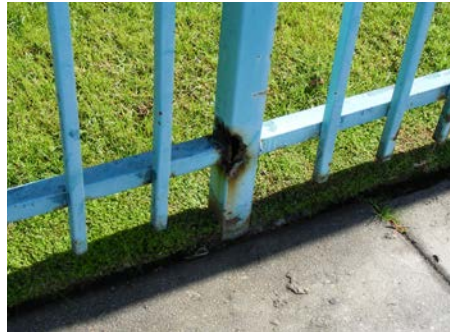
The metal fencing and gate are in need of paint and repair. Particularly, the area along the base of the front fencing where it has been effected by the landscape irrigation. The overspray condition as covered in Section 104. something has accelerated the typical degradation of the metal. Once the irrigation problem has been corrected, the affected areas should be repaired or replaced and the entire fence painted with a high-performance steel coating system in lieu of conventional paints. The high-performance coating will provide a chip- and fade-resistant life-cycle of up to 15 years, rather than the usual 5-7 years of conventional paint.

Rusted & Damaged Fencing

Repair and paint ornamental iron fencing with a high performance steel coating system.

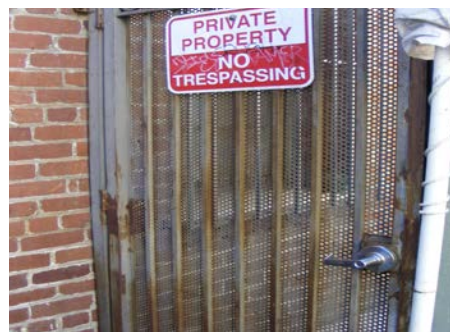
The gates are in need of repainting. We recommend that a high-performance steel coating system be used, in lieu of conventional paints. The high-performance coating will provide a chip- and fade-resistant life-cycle of up to 15 years, significantly greater than the usual 5-7 years of conventional paint.

Pedestrian Gate

Paint pedestrian gates with a high performance steel coating system.

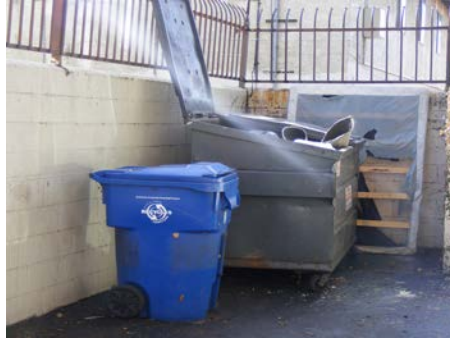
A trash enclosure does not currently exist. The trash bin is sitting in the open. We recommend installing an enclosure to better maintain property cleanliness.

Trash Enclosure

Install new trash enclosure.

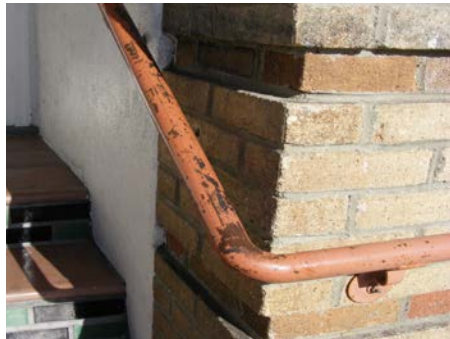
The guard railings throughout the property are in average condition, but are in need of painting to maintain and extend their useful life.

Guard Railing, Typical

Paint all guard rails with a high performance steel coating system.

We recommend repainting these items with a high-performance steel coating system in lieu of conventional paints. The high-performance coating will provide a chip- and fade-resistant life-cycle of up to 15 years, rather than the usual 5-7 years of conventional paint.

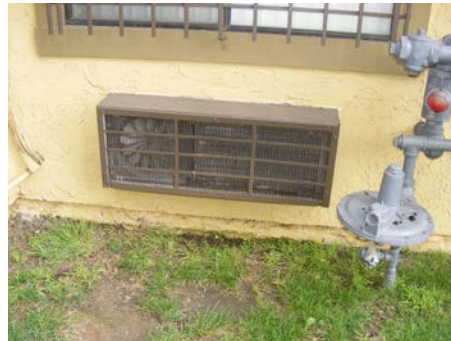
There is a 30 year old (dating from the original construction) HVAC unit serving the managers' office. This unit is at the end of its useful life and should be replaced.

PTAC Through-Wall Unit

Replace old HVAC unit.

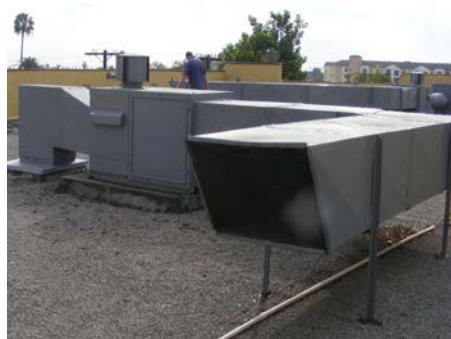
The building is equipped with corridor ventilation, but the fan is currently not functioning. We recommend that the inoperative fan be replaced so that the ventilation of the corridors is restored as soon as possible.

Roof Mounted Ventilation Equipment

Replace inoperative roof mounted fan for corridor ventilation system.

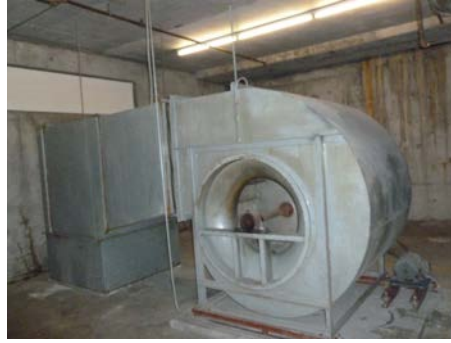
The garage ventilation system appears to be in moderate to good condition. The system is controlled with a time clock. The garage exhaust fan should be tested to verify its condition - and we recommend replacing it if it is in poor condition. A Carbon Monoxide (CO) fan control system should be added, so the system only turns on when the threshold CO levels are detected. We recommend that all the ductwork and grills be cleaned, tested and balanced.

Garage Ventilation Fan

Test garage exhaust fan; replace if necessary.

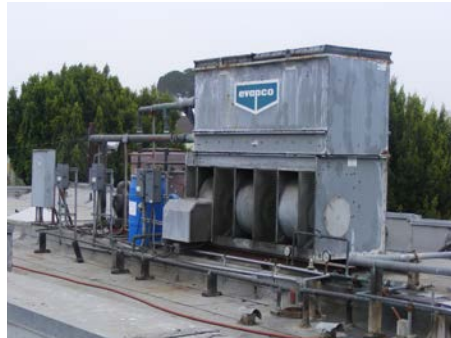
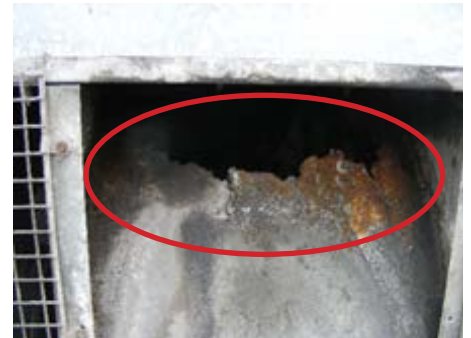
The equipment, located on the roof, that serves both the basement common areas and the tenant units is more than 15 years old, and is in very poor condition. The system has a history of blockages and failures that render the individual fan coils inoperative.

Cooling Tower and Hydronic Boiler

Rusted Fan Shroud on Cooling Tower

Replace hydronic boiler and cooling tower.

Replace individual fan coils in office and common areas.

We recommend that both the hydronic boiler and the cooling tower be replaced. The individual fan coils throughout the building must also be replaced as they are very inefficient and the majority of them are in poor condition.

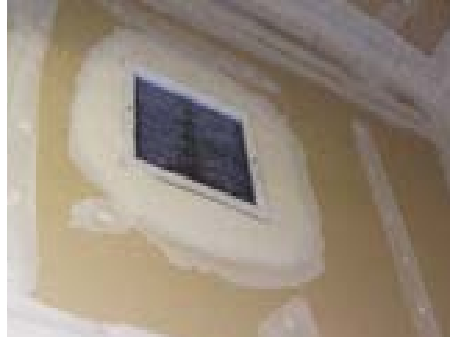
The elevator mechanical room, located in the basement, currently has a single exhaust fan to control the temperature in the room. We recommend replacing the exhaust fan with a cooling system to increase the reliability and longevity of the existing elevator equipment.

Sole Exhaust Grill In Elevator Room

Replace elevator mechanical room exhaust with HVAC.

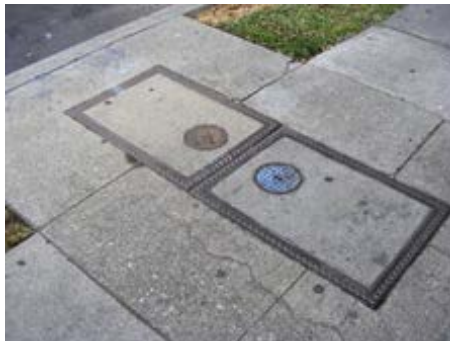
The building has separate water meters for both the domestic water supply and for the fire sprinkler service. Both meters are located along the west side of the building, and appear to be in average condition.

Water Mains in Public Sidewalk

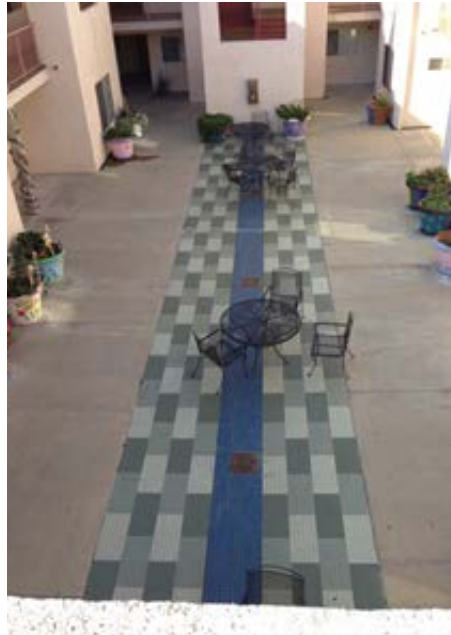
The upper courtyard is in fair condition with some damage and cracking to the topping slab. We recommend that all cracks be filled or caulked to limit further damage and minimize water intrusion into the garage area below.

Upper Courtyard

Repair or caulk all cracks in upper courtyard concrete.

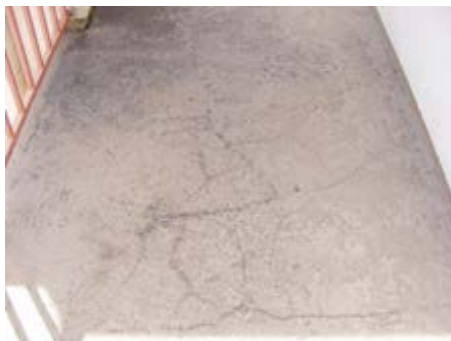
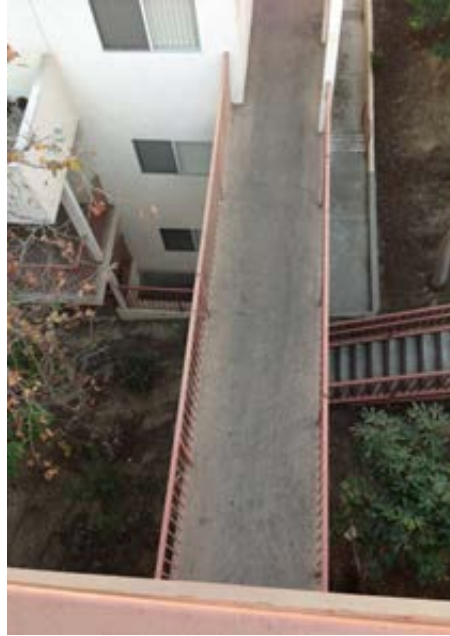
The traffic coating on the upper walkways is worn. There are several low spots causing ponding, and there are several areas of cracking. We recommend that the low areas be built up to better direct the flow of water and the deck coating be renewed to extend the life of the structure by preventing future water intrusion.

Cracked Deck Coating

Typical Walkway

Refresh deck coating on all walkways.

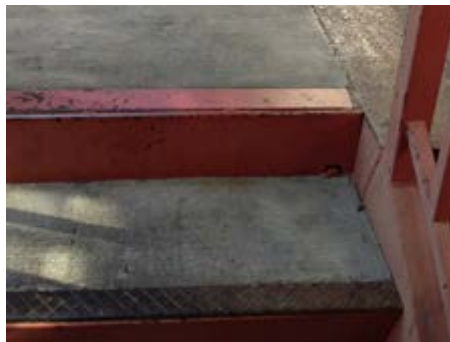
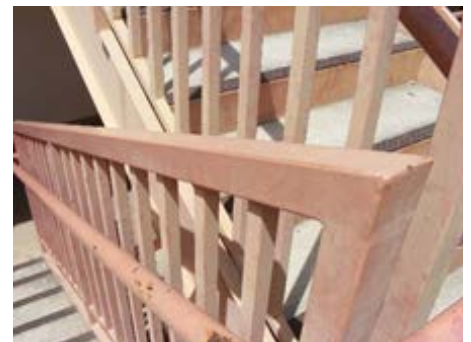
The exterior stairs are concrete with metal framing and are in average condition. The metal sections should be painted to extend their useful life. We recommend painting these items with a high-performance steel coating system in lieu of conventional paints. The high-performance coating will provide a chip- and fade-resistant life-cycle of up to 15 years, significantly greater than the usual 5-7 years of conventional paint.

Exterior Stair Condition, Typical

Exterior Guard Rail Condition, Typical

Paint metal portion of stairways with high-performance steel coating system.

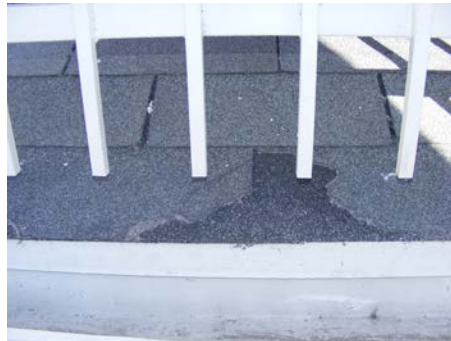
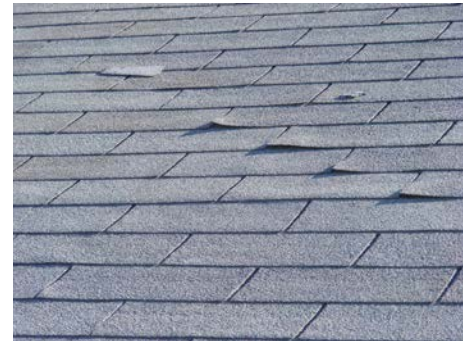
The roof consists mostly of asphalt shingle with some flat roof areas where the HVAC equipment is installed. The shingles have some areas where repairs are needed, but are otherwise in average condition. All of the mastic sealer on the penetrations should also be reapplied.

Damaged Roof Tile, Typical

Peeling Roof Tile, Typical

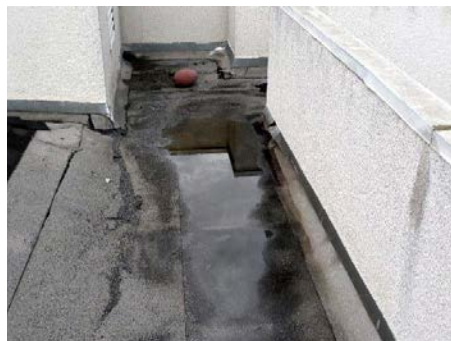
There are several soft and spongy areas in the flat sections of the roof deck. Some of these areas also show evidence of ponding, when they should be aiding the drainage of the roof system. This indicates weak sheathing. We recommend that all of these areas have the underlying roof sheathing replaced and be properly re-sloped to insure proper water flow.

Weak Roof Sheathing w/ Ponding

Replace roof sheathing and re-slope.

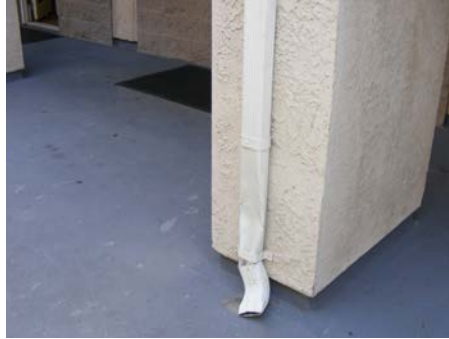
The roof gutters and downspouts have several areas of damage that should be repaired as soon as possible. The roof leaders that take water from the gutter down the wall are very light gauge, and in many places have pulled away. There are several locations where the piping is crushed potentially causing a stoppage and backup.

Crushed Downspout

Repair damaged gutters and replace downspouts throughout the site.

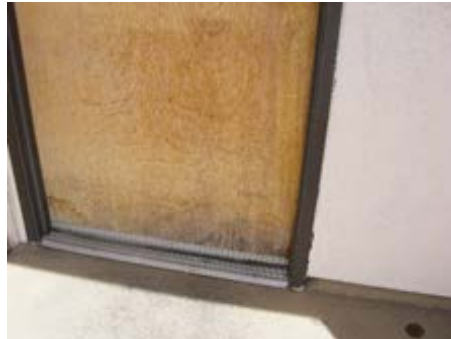
The unit entry doors are natural wood, solid core with a varnish finish. The majority of them are in poor condition and will need to be replaced. The remainder should be prepped and refinished to minimize future damage.

Damaged Entry Door

Replace all damaged unit entry doors.

Repair all exterior doors and refinish as required.

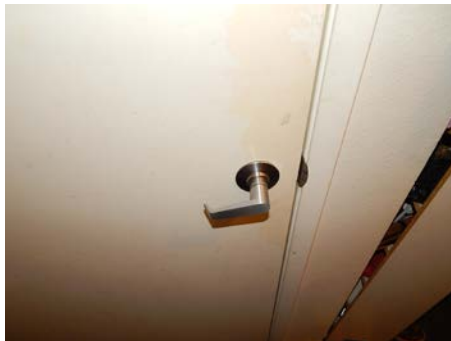
The unit interior doors are in average to fair condition, with some minor damage that can be repaired prior to the units being painted.

Interior Door, Typical

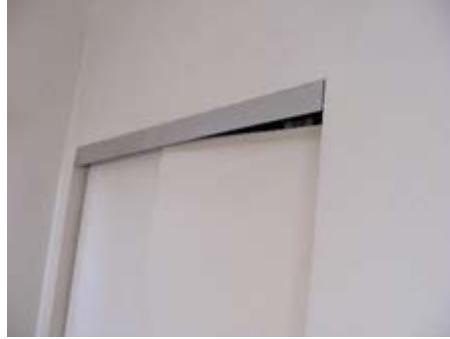
Closet Doors, Off Track

Replace sliding closet doors with lighter-weight metal-framed models.

We recommend that they be replaced with lighter-weight metal-framed models that will require less maintenance.

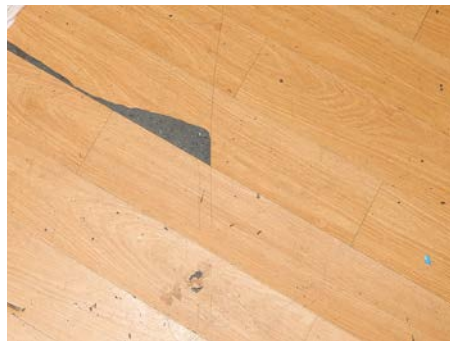
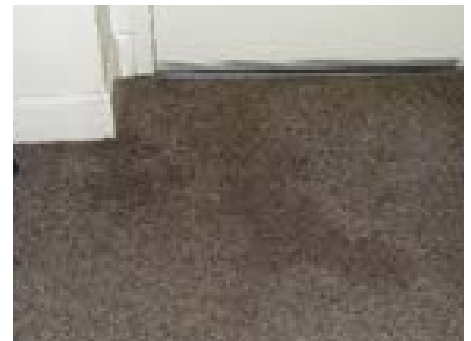
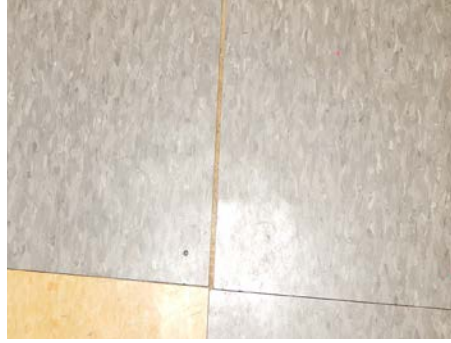
The carpeting and vinyl flooring in the units are in poor condition. In most units, the sheet vinyl is damaged, and the VCT has separated. This creates a condition where the surface can no longer easily be kept clean.

Damaged Kitchen Sheet Vinyl

Carpet Staining, Typical

Separated VCT Flooring

Replace all unit flooring.

We recommend that the flooring throughout all of the units be completely replaced. The VCT should be replaced with sheet vinyl.

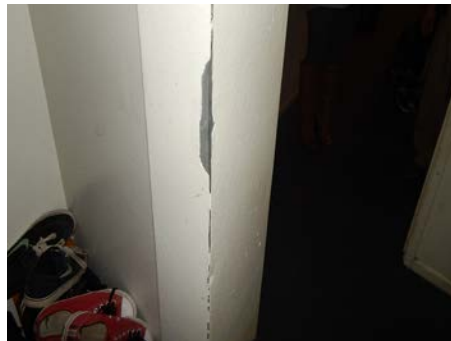
The paint in most units is in fair-to-poor condition. There is damage, mostly occurring at corners and behind doors, that should be repaired prior to painting.

Damage at Corner, Typical

Paint all unit interiors.

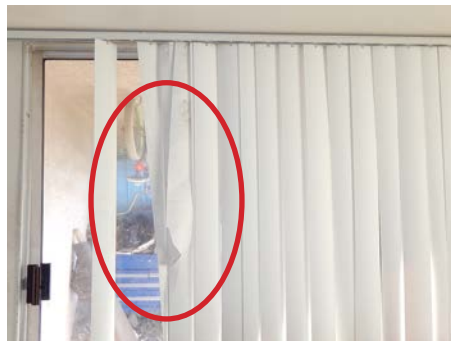
The window blinds throughout the buildings are damaged and in poor condition. We recommend that these vertical blinds be replaced.

Window Blinds, Typical

Replace all window blinds.

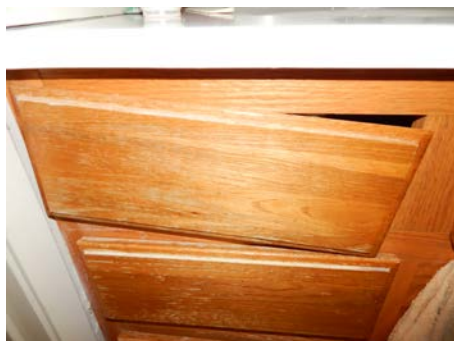
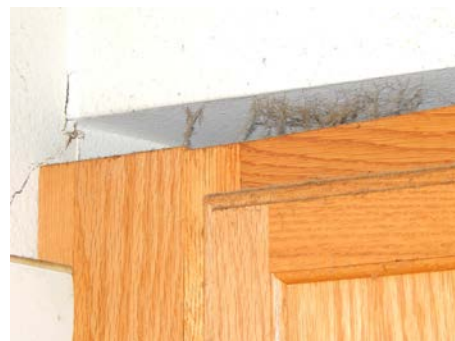
The kitchen cabinets show significant wear; have damaged drawers and cabinet hinges; and many assemblies are poorly installed, having been improperly sized for the area in which they are mounted.

Damaged Drawer

Improperly Installed Cabinets with Dust and Cobwebs

Replace all kitchen cabinets.

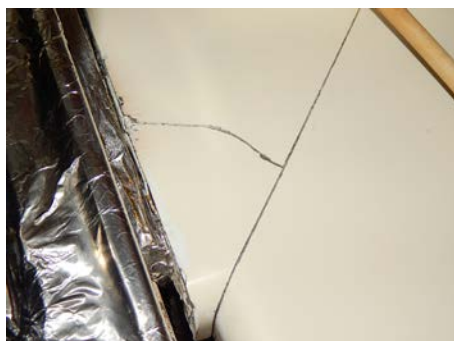
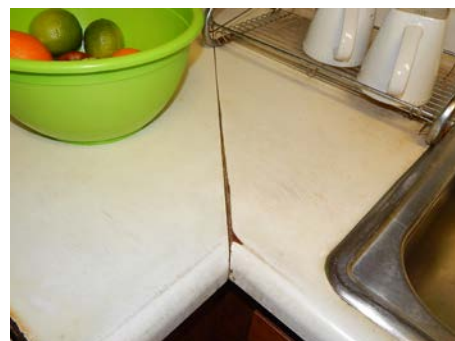
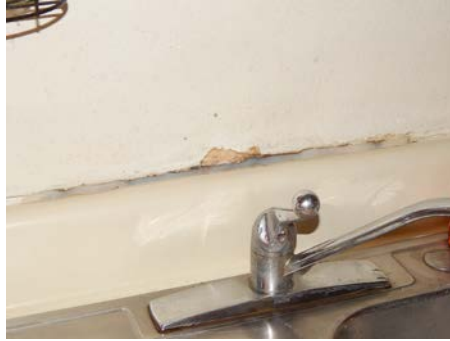
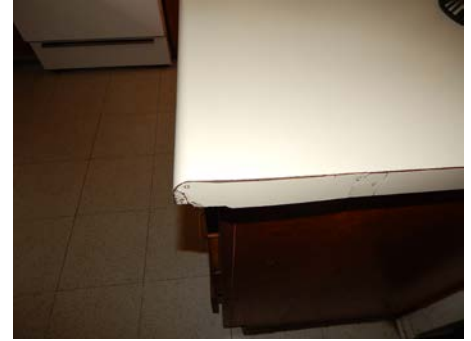
The countertops are in poor condition. They are worn and damaged; seams are open and the ends of the countertops are delaminated. This can create sanitary problems, as bacteria can accumulate that cannot be easily removed. They should be replaced with high-pressure laminate counters with a built-in drip edge, to minimize spillage onto the cabinet face.

Cracked Countertop

Wear & Separation

Water Damage Behind Sink

Delamination

The new countertops should utilize no-added-formaldehyde (NAF) or no-added-urea-formaldehyde (NAUF) products that comply with California Air Resources Board (CARB) Rules. Alternately, cabinets that carry the Composite Panel Association's Environmentally Preferable Product (EPP) rating can be used.

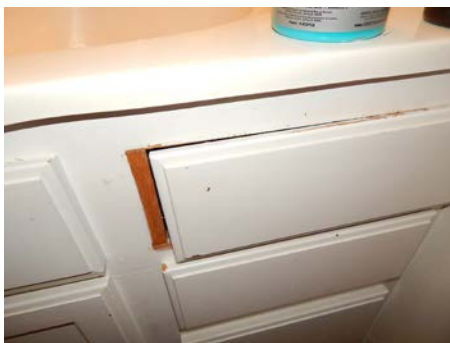
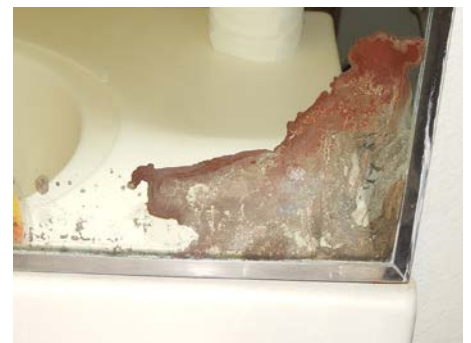
The majority of the vanity cabinets are in poor condition. In most cases there is evidence of water damage, as well as damaged drawer tracks and cabinet doors. We recommend that the damaged cabinets be replaced.

Damaged Vanity Drawers, Typical

Damaged Vanity Mirror, Typical

Replace damaged vanity assemblies.

Also, due to the demonstrated wear shown, future cabinets should be constructed of a more durable material with no-added-formaldehyde (NAF) or no-added-urea-formaldehyde (NAUF) products that comply with the California Air Resources Board (CARB) rules of 2012. Alternately, cabinets that carry the Composite Panel Association's Environmentally Preferable Product (EPP) rating can be used.

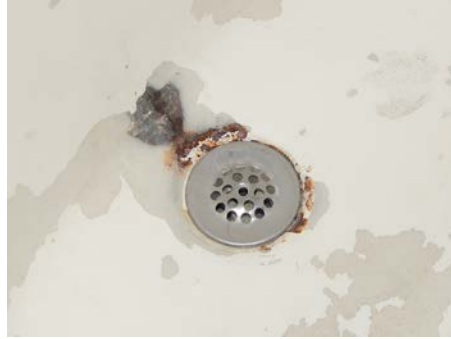
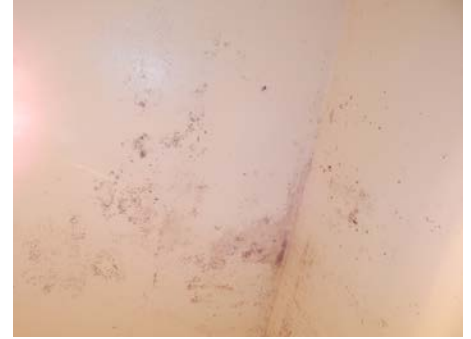
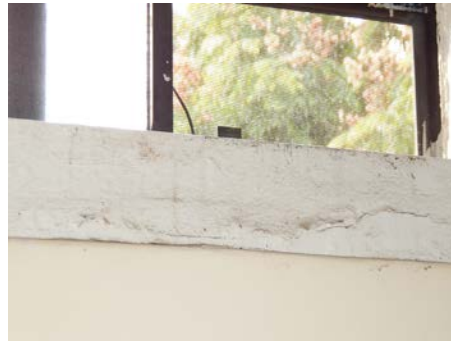
Most of the tubs, showers, and surrounds are in fair to poor condition. They have cracking in the surface finish and some have rust. The presence of mildew, along with warped drywall, suggests that bathroom exhaust is ineffective. This will be discussed further in "Section 404.070 - Bathroom Exhaust."

Damaged Tub Glaze w/ Rust

Mildew, Typical

Warped Drywall

Re-glaze all tubs and surrounds.

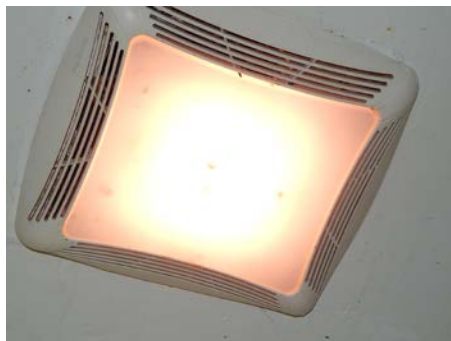
Most bathroom exhaust fixtures are in poor condition. The majority of them were not operable. As previously mentioned in "Section 404.030 - Tubs & Showers," there exists a significant amount of mildew and water related damage in the unit bathrooms throughout the building. This is likely due to the lack of operational exhaust fans.

Combination Light/Exhaust Fan, Typical

Replace all bathroom exhaust fixtures with new, energy efficient models.

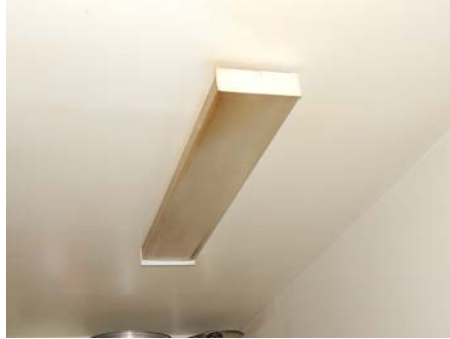
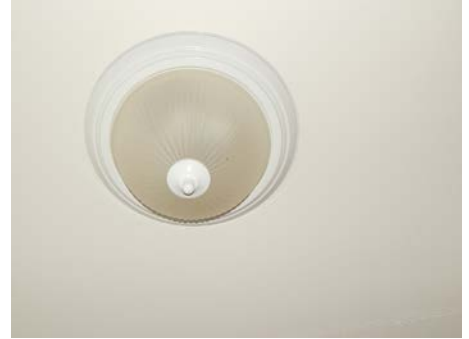
The unit lighting is represented by a variety of fixture types, none of which are high efficiency. The fluorescent fixtures are all T-12 fixtures, which are being phased out. The units should be retrofitted with new high efficiency fixtures, and the T-12 fixtures should be replaced with T-8 models.

T-12 Fixture, Typical

Standard Fixture, Typical

Retrofit all units with high efficiency lighting fixtures.

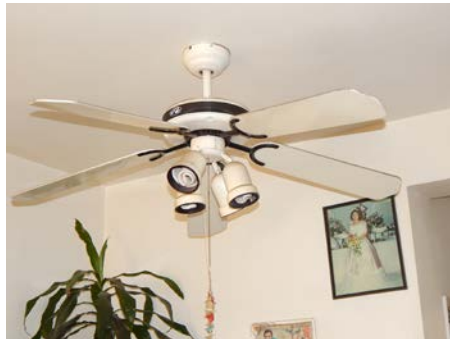
There are ceiling fans in about 30% of the units. Some may have been installed by tenants. Because ceiling fans can often be used as an alternative to turning on air conditioning, we recommend that new, EnergyStar rated models be installed in every unit.

Ceiling Fan, Typical

Install new, EnergyStar rated ceiling fans in all units.
