*Physical Needs Assessment*

# Happy Community Apts.

111 Sample Blvd.

September 20th, 2014

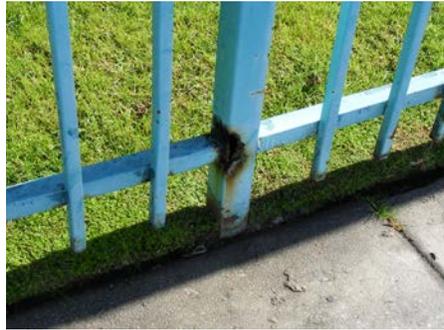
The metal fencing and gate are in need of paint and repair. Particularly, the area along the base of the front fencing where it has been effected by the landscape irrigation. The overspray condition as covered in Section 104. something has accelerated the typical degradation of the metal. Once the irrigation problem has been corrected, the affected areas should be repaired or replaced and the entire fence painted with a high-performance steel coating system in lieu of conventional paints. The high-performance coating will provide a chip- and fade-resistant life-cycle of up to 15 years, rather than the usual 5-7 years of conventional paint.

Rusted & Damaged Fencing

Repair and paint ornamental iron fencing with a high performance steel coating system.

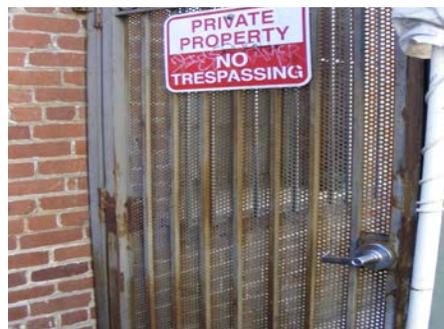
The gates are in need of repainting. We recommend that a high-performance steel coating system be used, in lieu of conventional paints. The high-performance coating will provide a chip- and fade-resistant life-cycle of up to 15 years, significantly greater than the usual 5-7 years of conventional paint.

Pedestrian Gate

Paint pedestrian gates with a high performance steel coating system.

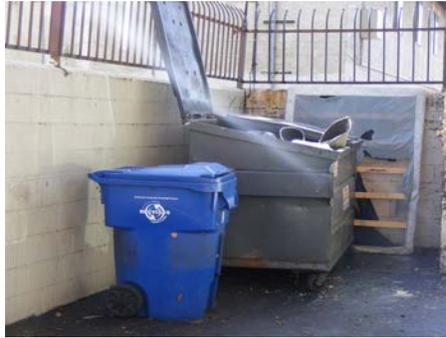
A trash enclosure does not currently exist. The trash bin is sitting in the open. We recommend installing an enclosure to better maintain property cleanliness.

Trash Enclosure

Install new trash enclosure.

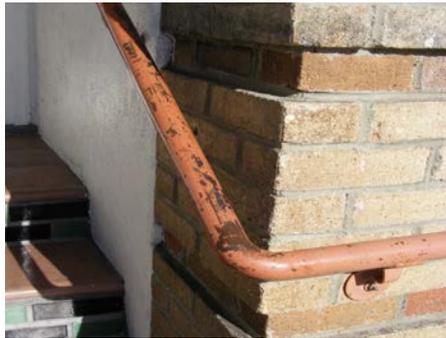
The guard railings throughout the property are in average condition, but are in need of painting to maintain and extend their useful life.

Guard Railing, Typical

We recommend repainting these items with a high-performance steel coating system in lieu of conventional paints. The high-performance coating will provide a chip- and fade-resistant life-cycle of up to 15 years, rather than the usual 5-7 years of conventional paint.

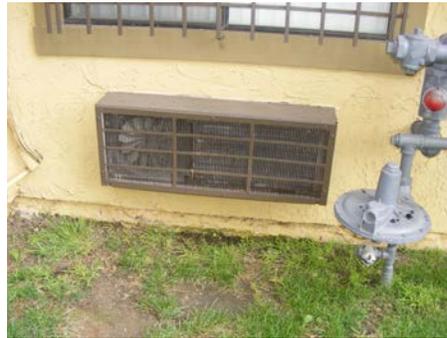
There is a 30 year old (dating from the original construction) HVAC unit serving the managers' office. This unit is at the end of its useful life and should be replaced.

PTAC Through-Wall Unit

Replace old HVAC unit.

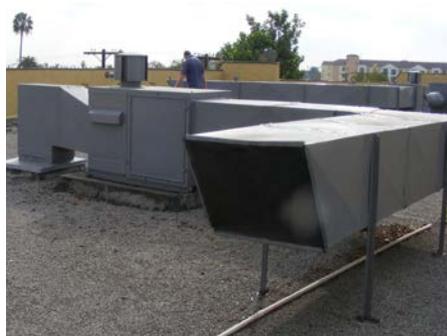
The building is equipped with corridor ventilation, but the fan is currently not functioning. We recommend that the inoperative fan be replaced so that the ventilation of the corridors is restored as soon as possible.

Roof Mounted Ventilation Equipment

Replace inoperative roof mounted fan for corridor ventilation system.

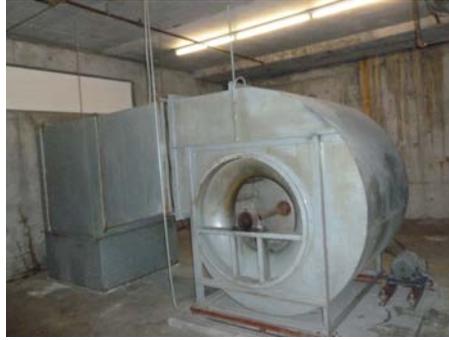
The garage ventilation system appears to be in moderate to good condition. The system is controlled with a time clock. The garage exhaust fan should be tested to verify its condition - and we recommend replacing it if it is in poor condition. A Carbon Monoxide (CO) fan control system should be added, so the system only turns on when the threshold CO levels are detected. We recommend that all the ductwork and grills be cleaned, tested and balanced.

Garage Ventilation Fan

Test garage exhaust fan; replace if necessary.

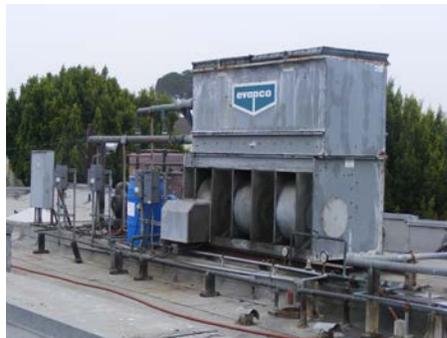
The equipment, located on the roof, that serves both the basement common areas and the tenant units is more than 15 years old, and is in very poor condition. The system has a history of blockages and failures that render the individual fan coils inoperative.

Cooling Tower and Hydronic Boiler

We recommend that both the hydronic boiler and the cooling tower be replaced. The individual fan coils throughout the building must also be replaced as they are very inefficient and the majority of them are in poor condition.

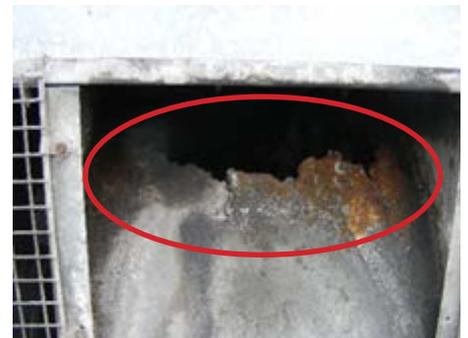
Rusted Fan Shroud on Cooling Tower

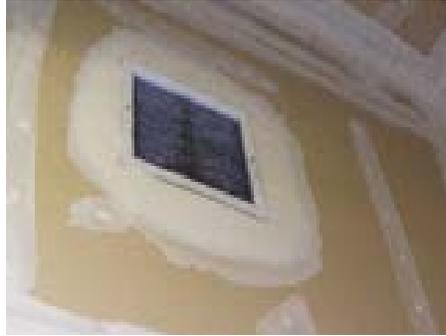
The elevator mechanical room, located in the basement, currently has a single exhaust fan to control the temperature in the room. We recommend replacing the exhaust fan with a cooling system to increase the reliability and longevity of the existing elevator equipment.

Sole Exhaust Grill In Elevator Room

Replace elevator mechanical room exhaust with HVAC.

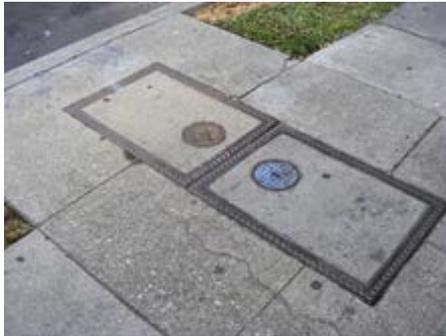
The building has separate water meters for both the domestic water supply and for the fire sprinkler service. Both meters are located along the west side of the building, and appear to be in average condition.

Water Mains in Public Sidewalk

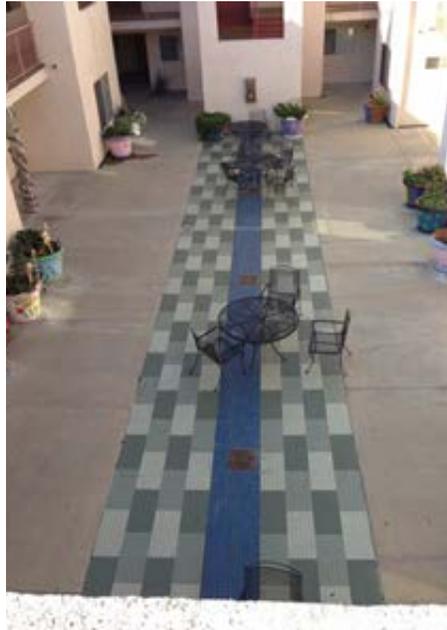
The upper courtyard is in fair condition with some damage and cracking to the topping slab. We recommend that all cracks be filled or caulked to limit further damage and minimize water intrusion into the garage area below.

Upper Courtyard

Repair or caulk all cracks in upper courtyard concrete.

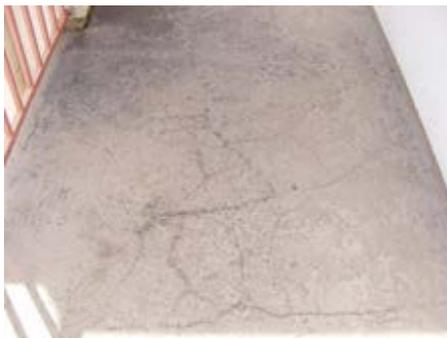
The traffic coating on the upper walkways is worn. There are several low spots causing ponding, and there are several areas of cracking. We recommend that the low areas be built up to better direct the flow of water and the deck coating be renewed to extend the life of the structure by preventing future water intrusion.

Cracked Deck Coating

Refresh deck coating on all walkways.

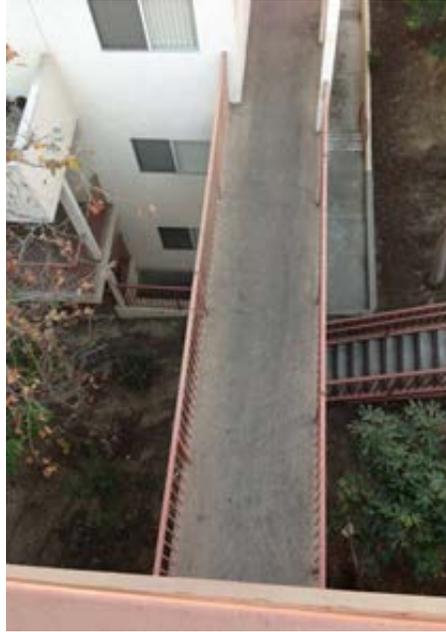
Typical Walkway

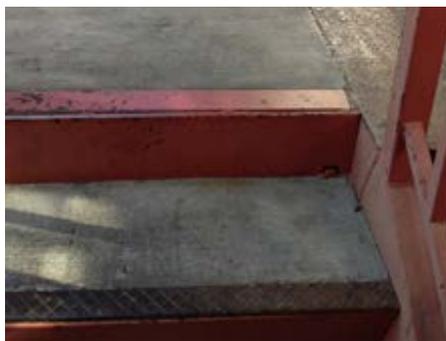
The exterior stairs are concrete with metal framing and are in average condition. The metal sections should be painted to extend their useful life. We recommend painting these items with a high-performance steel coating system in lieu of conventional paints. The high-performance coating will provide a chip- and fade-resistant life-cycle of up to 15 years, significantly greater than the usual 5-7 years of conventional paint.

Exterior Stair Condition, Typical

Paint metal portion of stairways with high-performance steel coating system.

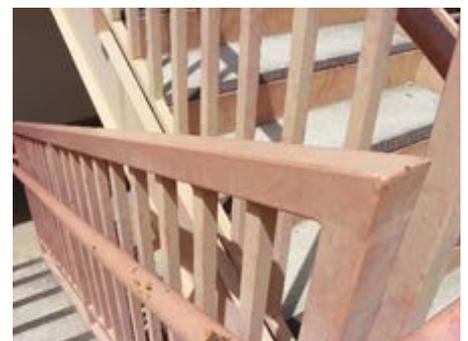
Exterior Guard Rail Condition, Typical

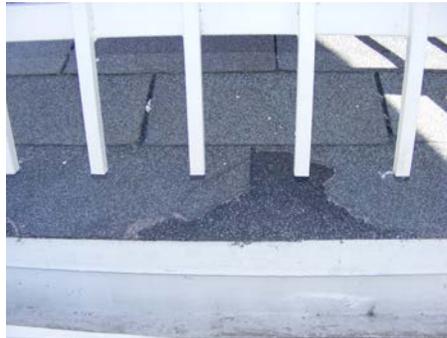
The roof consists mostly of asphalt shingle with some flat roof areas where the HVAC equipment is installed. The shingles have some areas where repairs are needed, but are otherwise in average condition. All of the mastic sealer on the penetrations should also be reapplied.

Damaged Roof Tile, Typical

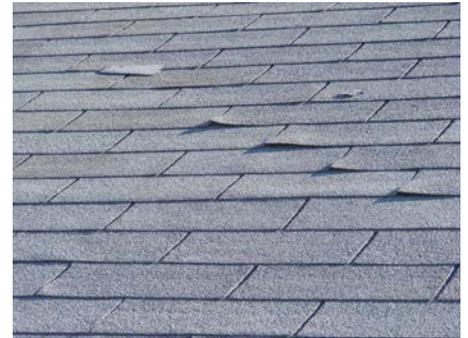
Peeling Roof Tile, Typical

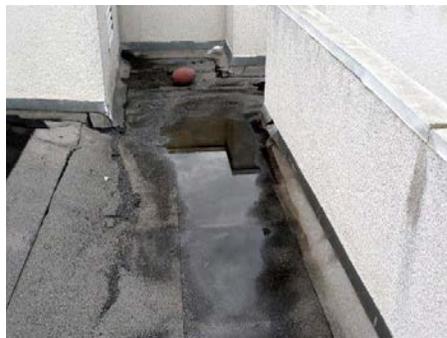
There are several soft and spongy areas in the flat sections of the roof deck. Some of these areas also show evidence of ponding, when they should be aiding the drainage of the roof system. This indicates weak sheathing. We recommend that all of these areas have the underlying roof sheathing replaced and be properly re-sloped to insure proper water flow.

Weak Roof Sheathing w/ Ponding

Replace roof sheathing and re-slope.

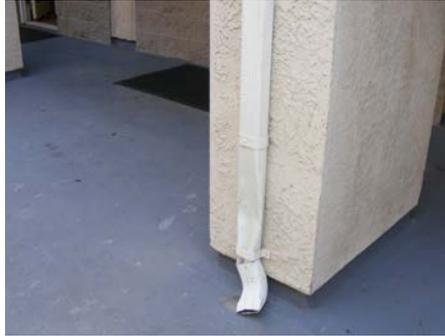
The roof gutters and downspouts have several areas of damage that should be repaired as soon as possible. The roof leaders that take water from the gutter down the wall are very light gauge, and in many places have pulled away. There are several locations where the piping is crushed potentially causing a stoppage and backup.

Crushed Downspout

Repair damaged gutters and replace downspouts throughout the site.

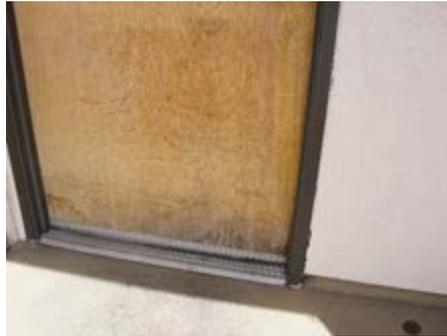
The unit entry doors are natural wood, solid core with a varnish finish. The majority of them are in poor condition and will need to be replaced. The remainder should be prepped and refinished to minimize future damage.

Damaged Entry Door

Replace all damaged unit entry doors.

Repair all exterior doors and refinish as required.

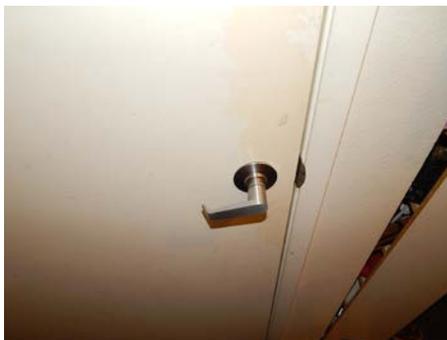
The unit interior doors are in average to fair condition, with some minor damage that can be repaired prior to the units being painted.

Interior Door, Typical

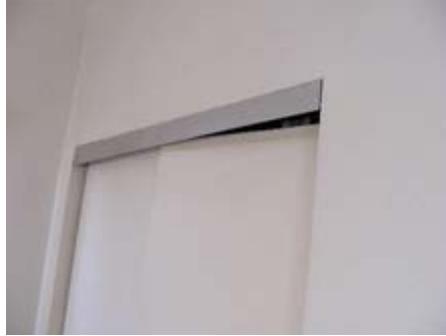
Closet Doors, Off Track

Replace sliding closet doors with lighter-weight metal-framed models.

We recommend that they be replaced with lighter-weight metal-framed models that will require less maintenance.

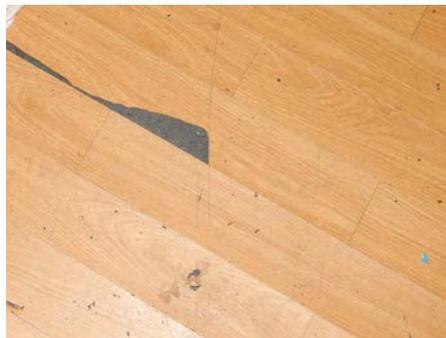
The carpeting and vinyl flooring in the units are in poor condition. In most units, the sheet vinyl is damaged, and the VCT has separated. This creates a condition where the surface can no longer easily be kept clean.

Damaged Kitchen Sheet Vinyl

We recommend that the flooring throughout all of the units be completely replaced. The VCT should be replaced with sheet vinyl.

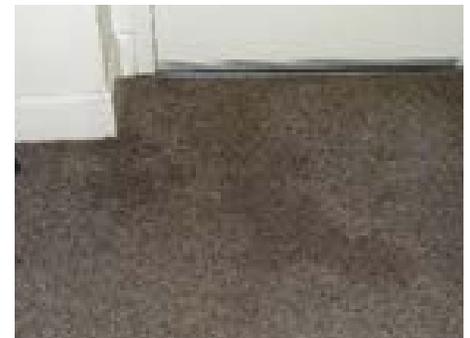
Carpet Staining, Typical

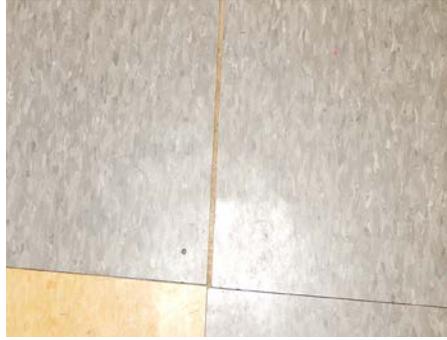
Separated VCT Flooring

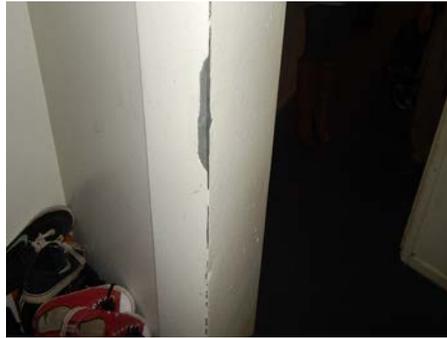
The paint in most units is in fair-to-poor condition. There is damage, mostly occurring at corners and behind doors, that should be repaired prior to painting.

Damage at Corner, Typical

Paint all unit interiors.

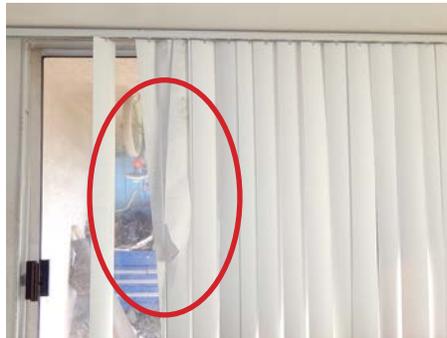
The window blinds throughout the buildings are damaged and in poor condition. We recommend that these vertical blinds be replaced.

Window Blinds, Typical

Replace all window blinds.

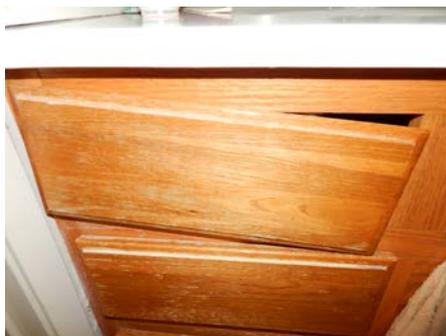
The kitchen cabinets show significant wear; have damaged drawers and cabinet hinges; and many assemblies are poorly installed, having been improperly sized for the area in which they are mounted.

Damaged Drawer

Replace all kitchen cabinets.

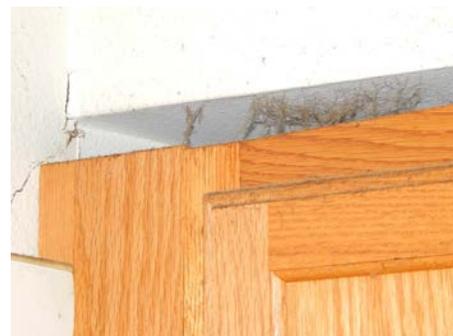
Improperly Installed Cabinets with Dust and Cobwebs

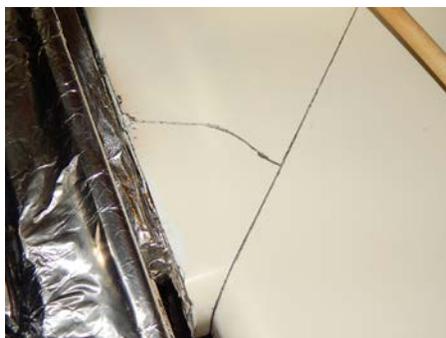
The countertops are in poor condition. They are worn and damaged; seams are open and the ends of the countertops are delaminated. This can create sanitary problems, as bacteria can accumulate that cannot be easily removed. They should be replaced with high-pressure laminate counters with a built-in drip edge, to minimize spillage onto the cabinet face.

Cracked Countertop

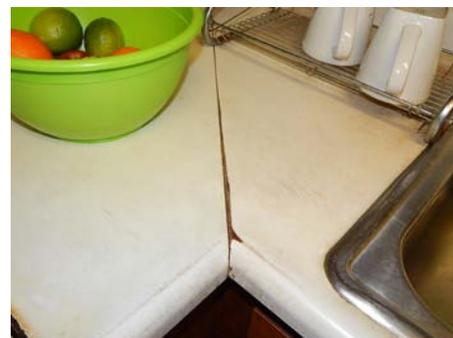
Wear & Separation

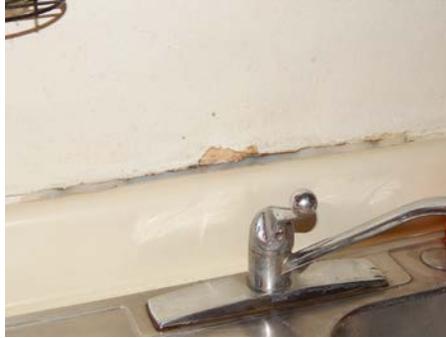
Water Damage Behind Sink

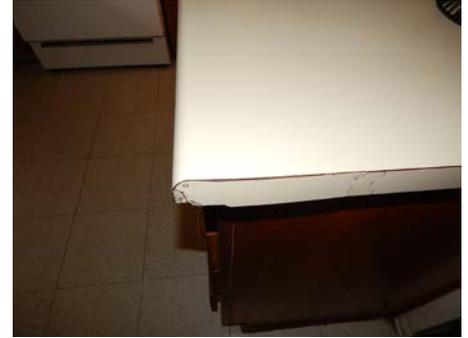
Delamination

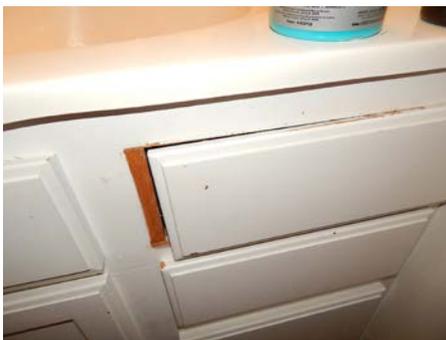
The majority of the vanity cabinets are in poor condition. In most cases there is evidence of water damage, as well as damaged drawer tracks and cabinet doors. We recommend that the damaged cabinets be replaced.

Damaged Vanity Drawers, Typical

Replace damaged vanity assemblies.

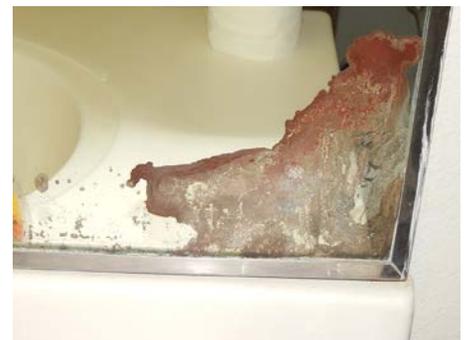
Damaged Vanity Mirror, Typical

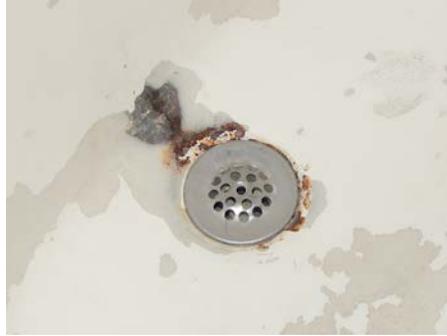
Most of the tubs, showers, and surrounds are in fair to poor condition. They have cracking in the surface finish and some have rust. The presence of mildew, along with warped drywall, suggests that bathroom exhaust is ineffective. This will be discussed further in "Section 404.070 - Bathroom Exhaust."

Damaged Tub Glaze w/ Rust

Re-glaze all tubs and surrounds.

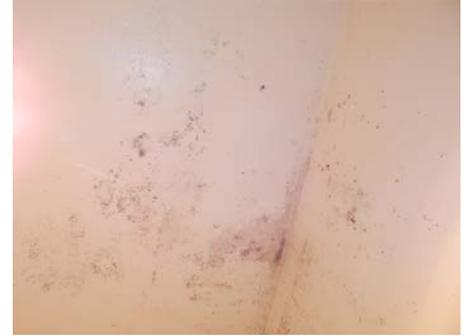
Mildew, Typical

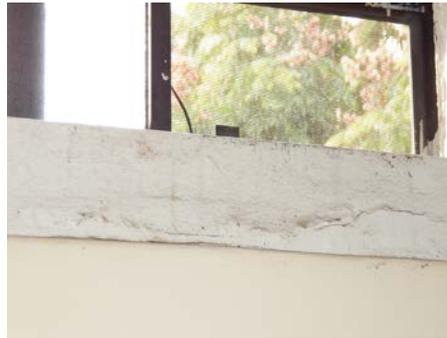
Warped Drywall

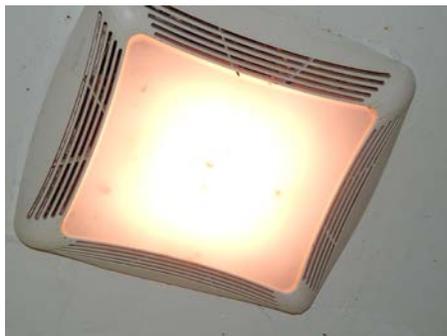
Most bathroom exhaust fixtures are in poor condition. The majority of them were not operable. As previously mentioned in "Section 404.030 - Tubs & Showers," there exists a significant amount of mildew and water related damage in the unit bathrooms throughout the building. This is likely due to the lack of operational exhaust fans.

Combination Light/Exhaust Fan, Typical

Replace all bathroom exhaust fixtures with new, energy efficient models.

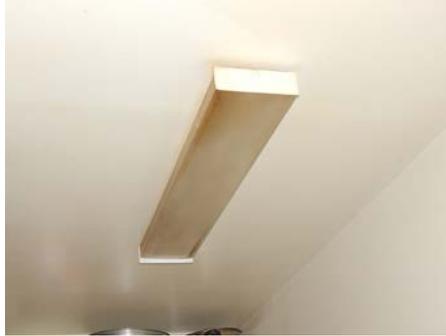
The unit lighting is represented by a variety of fixture types, none of which are high efficiency. The fluorescent fixtures are all T-12 fixtures, which are being phased out. The units should be retrofitted with new high efficiency fixtures, and the T-12 fixtures should be replaced with T-8 models.

T-12 Fixture, Typical

Retrofit all units with high efficiency lighting fixtures.

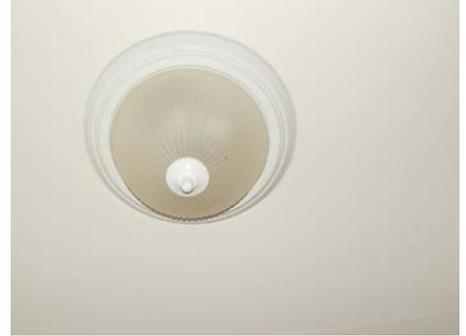
Standard Fixture, Typical

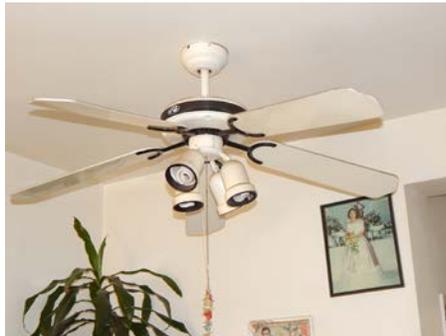
There are ceiling fans in about 30% of the units. Some may have been installed by tenants. Because ceiling fans can often be used as an alternative to turning on air conditioning, we recommend that new, EnergyStar rated models be installed in every unit.

Ceiling Fan, Typical

Install new, EnergyStar rated ceiling fans in all units.
